Manhole Inspection Summary

Manhole # S69C1_008MH

Insp Date: **2/20/08 12:48 PM**

Location Address: **2216 Ralls Ave.**

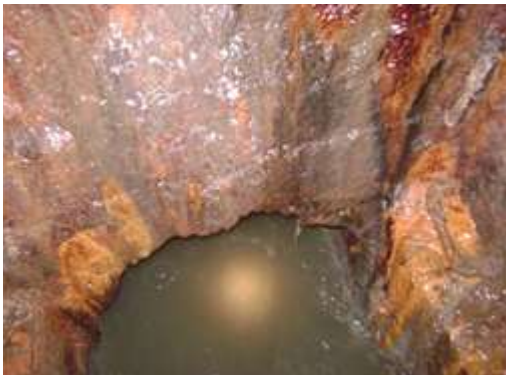
Defect 1

Condition: ☐ Sound ☐ Cracked ☐ Root Intrusion ☒ **Deteriorated** ☐ Leaks ☐ Debris

Heavy mineral deposits outgoing 12 O'Clock

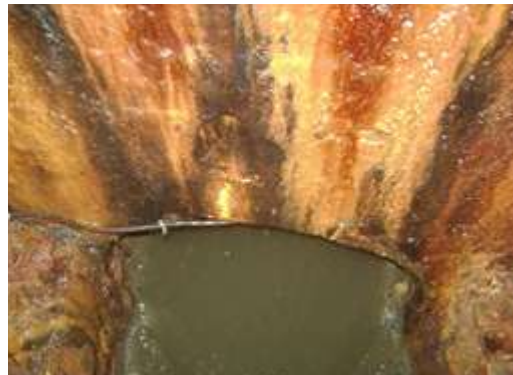
Defect 2

Heavy mineral deposits incoming 6 O'Clock and on bench.

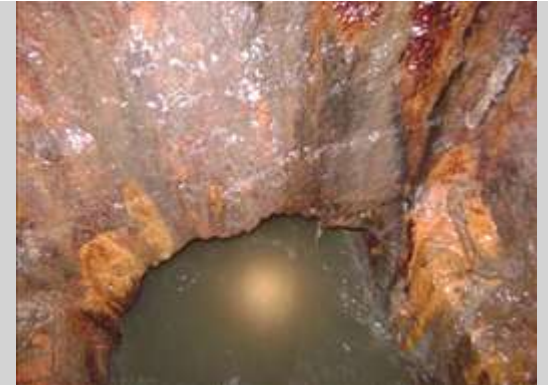
12 O'Clock Outflow

36 in. Circular Gravity Sewer
Pipe Out @ 12 O'Clock

Pipe Height: **36** (in.) Rod Only

Pipe Material: **Concrete** ☐ Pipe Lined

Invert Depth: **31.42** (ft.) Flow Characteristics: **Fast**

Infiltration: **None** Pipe Seal Cond: **Sound**

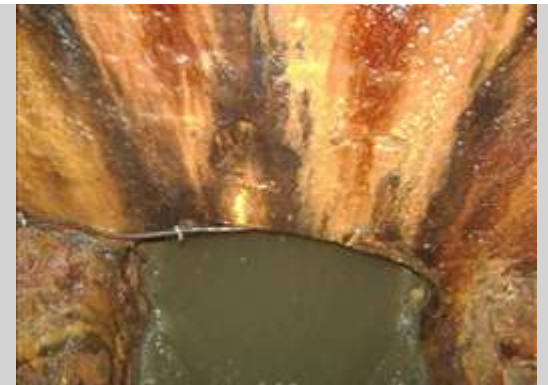
6 O'Clock Inflow

36 in. Circular Gravity Sewer
Pipe In @ 6 O'Clock

Pipe Height: **36** (in.) Rod Only

Pipe Material: **Concrete** ☐ Pipe Lined

Invert Depth: **31.38** (ft.) Flow Characteristics: **Fast**

Infiltration: **None** Pipe Seal Cond: **Sound**

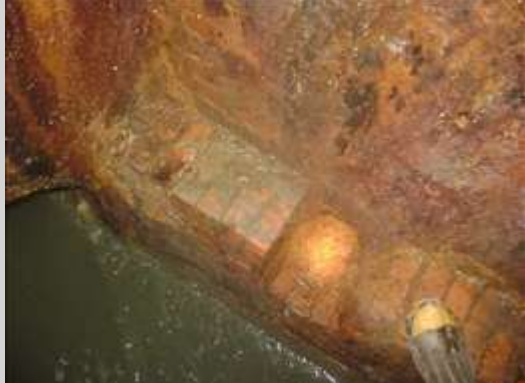
9 O'Clock Inflow

8 in. Circular Gravity Sewer

Pipe In @ 9 O'Clock

Pipe Height: **8.4** (in.) Rod Only

Pipe Material: **Clay** ☐ Pipe Lined

Invert Depth: **29.50** (ft.) Flow Characteristics: **None**

Infiltration: **None** Pipe Seal Cond: **Sound**

Connects To: **Dead End**
